Banská Štiavnica in Renaissance-Baroque period: Trusses Recognition, survey, documentation and research of historical trusses

**AUTUMN
UNIVERSITY OF
ARCHITECTURE
2024**
14th Students Workshop
29.9. – 5.10.2024

ST. CATHERINE'S CHURCH _ M _ RADNIČNÉ NÁMESTIE 100/17 _ TRUSS

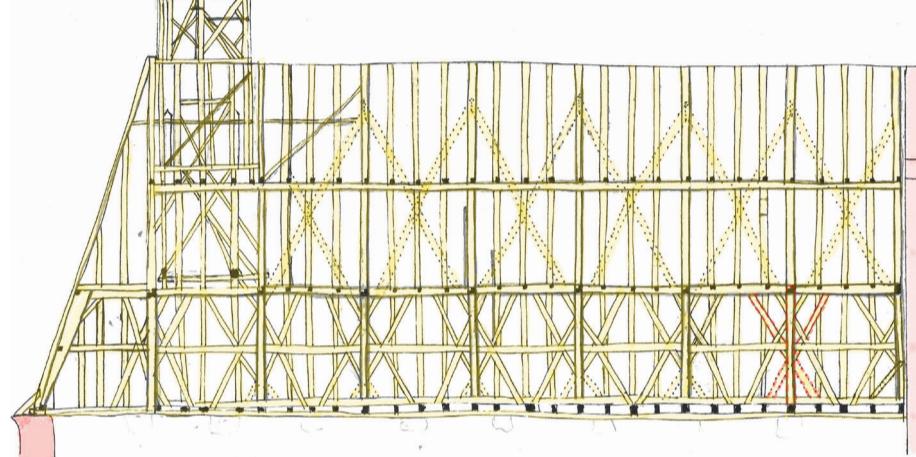
LONGITUDINAL SECTION

However, the roof truss, preserved from the reconstruction between the years 1654 and 1655 (replacing an unknown earlier form) is the most telling of the building's history. The trussed rafter roof consists of 24 frames: 8 full bonds and 16 intermediate ones. It carries a steeply pitched gabled roof with a multi-pitched southeastern hipped roof, two rows of dormers with flat roofs and an octagonal ridge turret over the centre of the nave. All the sloping supports of the rafters are decorated with „tongues“ highlighted in red, some of them additionally decorated with wavy bands of red polychrome. The sources do not indicate the specific reason for the polychrome design, so it is possible to assume that it was but an aesthetic addition. On the third rafter from the brick gable the initials „GSZM“ have been preserved, enriched with the date of the truss design „1655“. While the significance of the initials has not yet been clarified – it is only known that they were inscribed during the Protestant tenure of the church – the authenticity of the dating has been verified by dendrochronology. The initials should be the subject of further research. The signature „S. (?) HALAC ST.“ was newly recorded on the collar beam of the first full bond, and the initials „LB.“ on the fourth rafter from the gable. Carpenter's marks were also recorded on all parts of the truss.

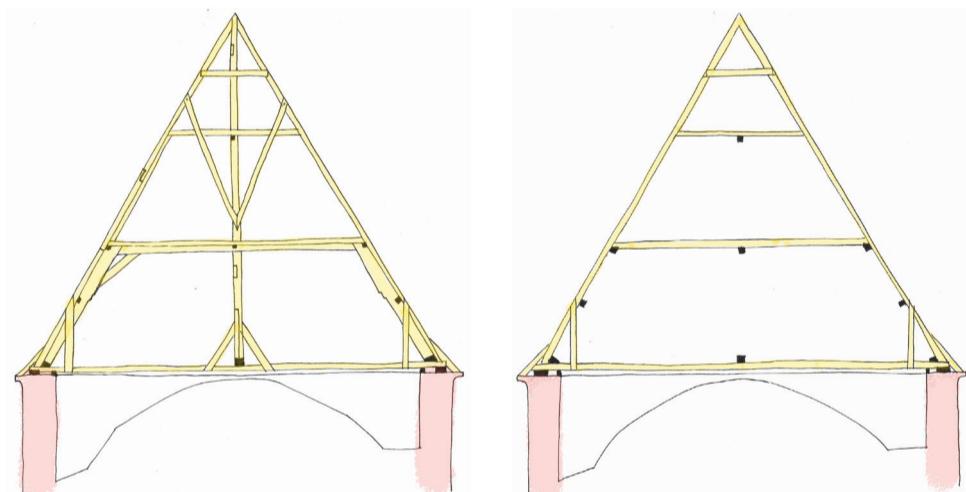
CROSS SECTION _ FULL FRAME

CROSS SECTION _ EMPTY FRAME

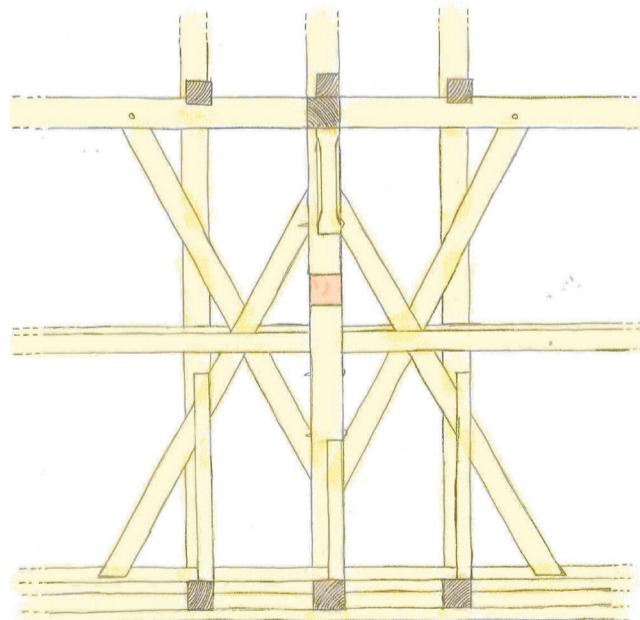
DETAIL OF LONGITUDINAL SECTION
full frame with st. Andrew's crosses and nearby empty frames

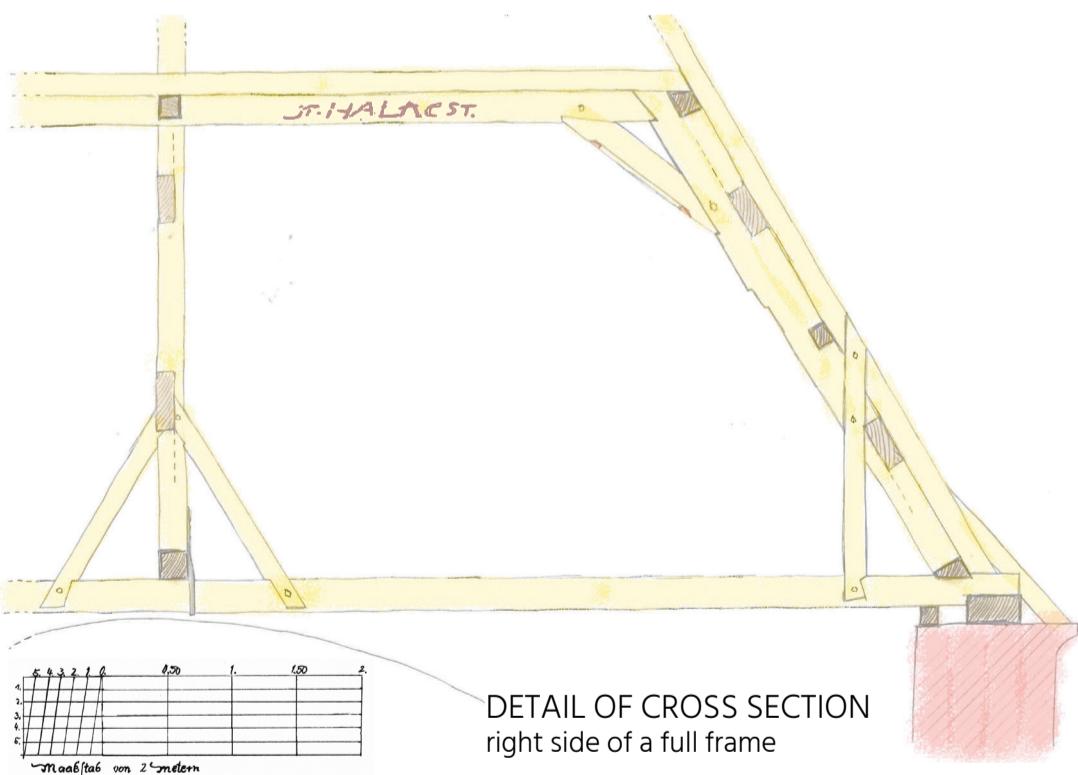
DETAIL OF CROSS SECTION
right side of a full frame

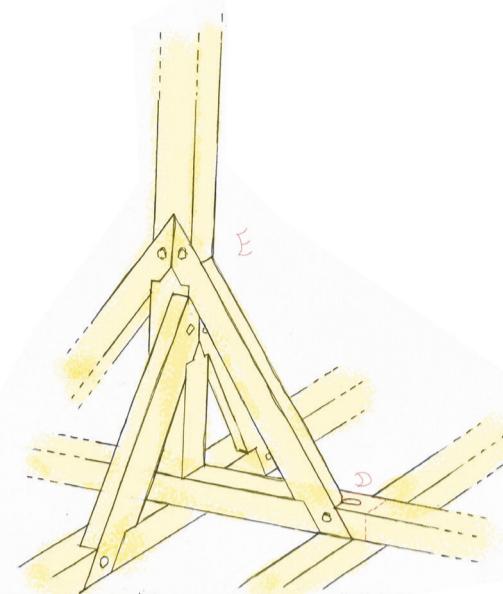
ISOMETRIC DRAWING

two sides of the structure connecting the post with the beams

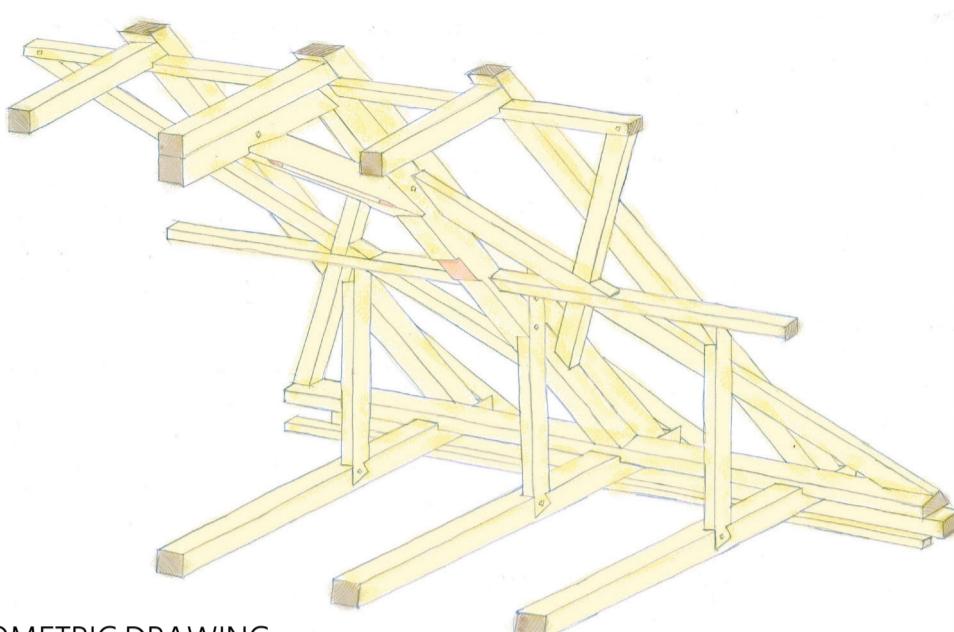
ISOMETRIC DRAWING

the rafters of a full frame and two surrounding empty frames connected with st. Andrew's crosses

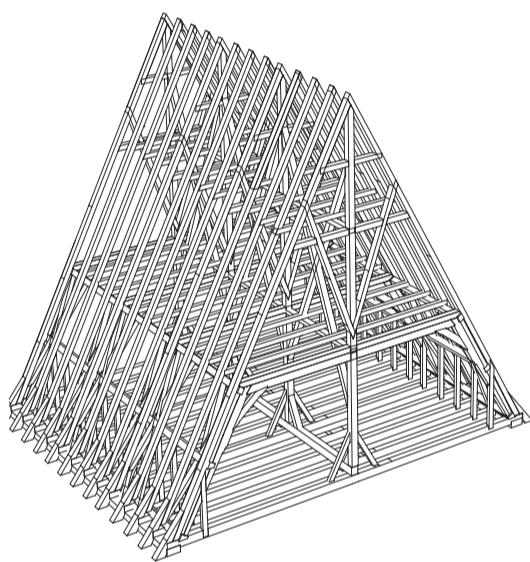
Vector 3D model of the truss modeled in AutoCad.

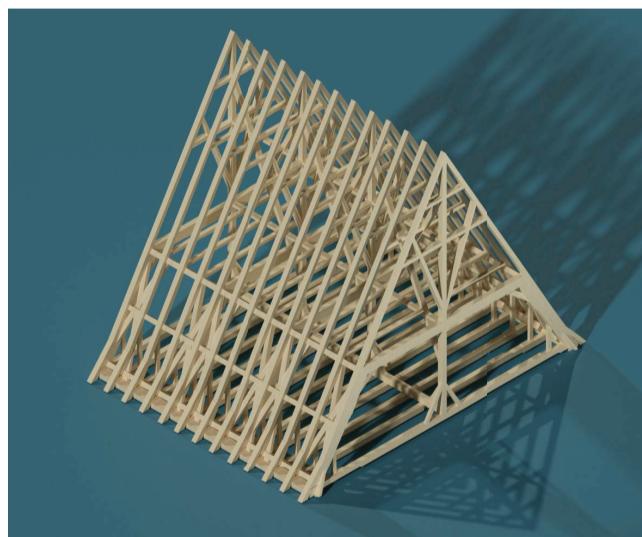
3D model of the truss with texture.

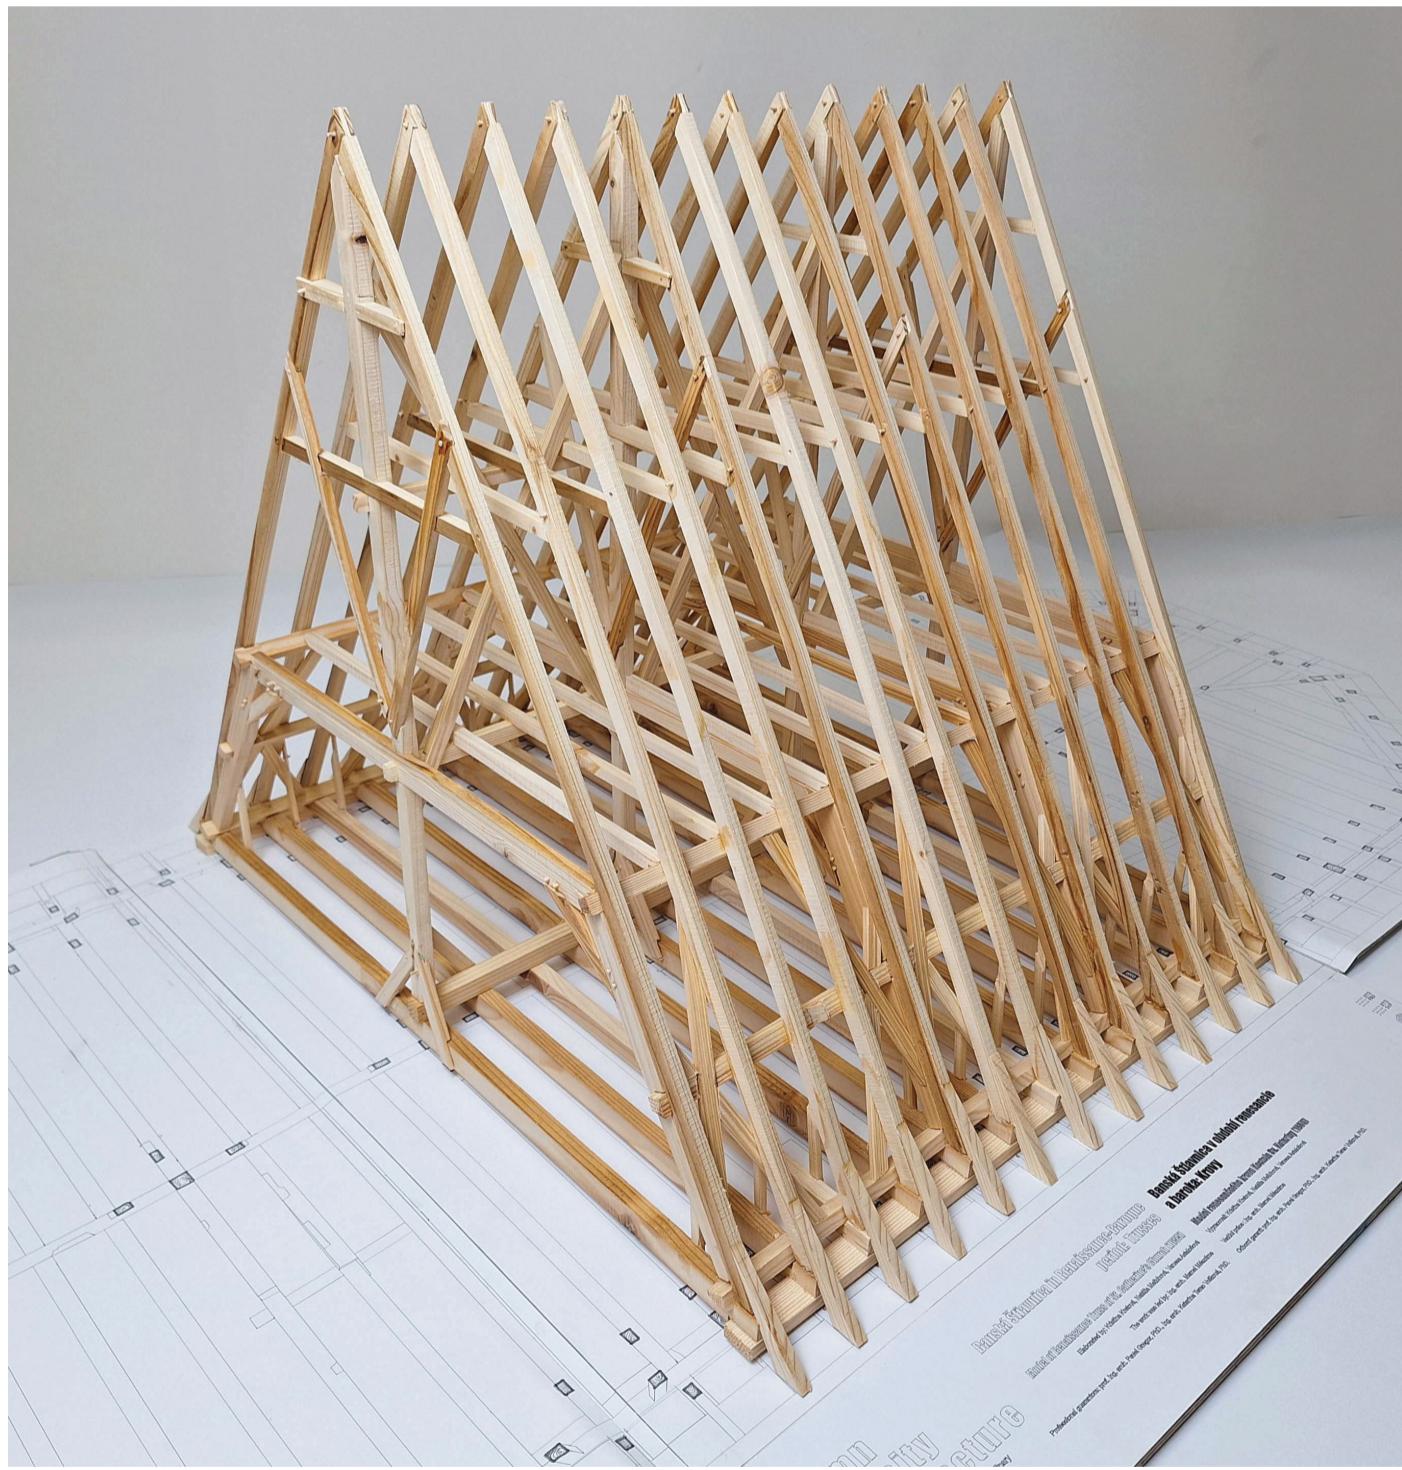
Physical,final model of the truss in scale 1:20.

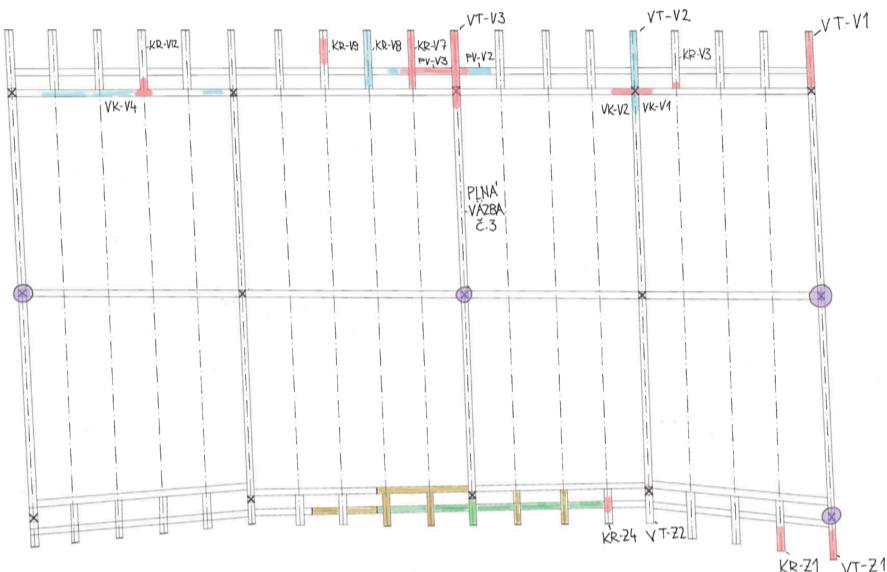
PÔDORYS VÝCHODNÉHO KRÍDLA
Floorplan of east wing

The diagnostics were conducted on the eastern wing of the roof structure of the Limpacher House. The roof underwent a major reconstruction in 2006. The preserved section of the roof dates back to the 18th century and consists of a system of leaning trestles. In the longitudinal direction, the roof is braced by longitudinal struts mortised into the leaning posts and diagonal passing braces. The main cause of structural damage were dormers with missing window infills, through which rainwater entered the structure over a long period. Damage of the tie beam trimmer caused by moisture, along with the insufficient strength of its joints with shortened tie beams weakens the structure's ability to withstand shear forces. Following the 2006 reconstruction, some elements of longitudinal bracing are missing. Certain details connecting the new construction phase to the original roof are insufficient. Damage caused by the House Longhorn Beetle (*Hylotrupes bajulus* L.) and insects from the Anobiidae family was identified. Based on the diagnostics, a thorough restoration of the roof is recommended, focusing on the removal of biological damage and the addition of missing longitudinal bracing elements, including modifications to the 2006 construction. All proposed solutions must be consulted with and approved by a structural engineer.

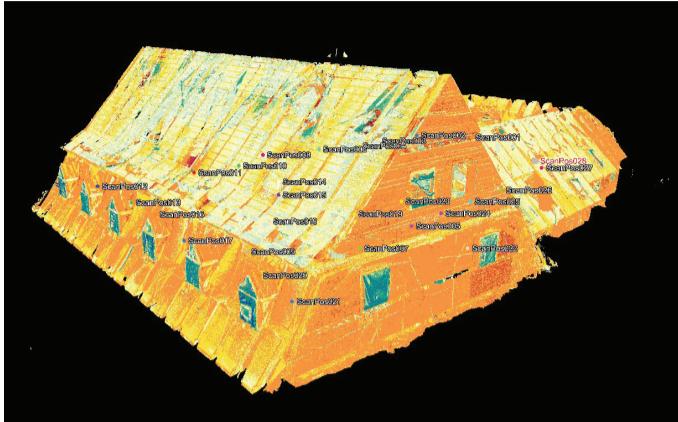
SPRACOVANIE MRAČNA BODOV V PROGR. RISCAN
Point cloud processing in Riscan software

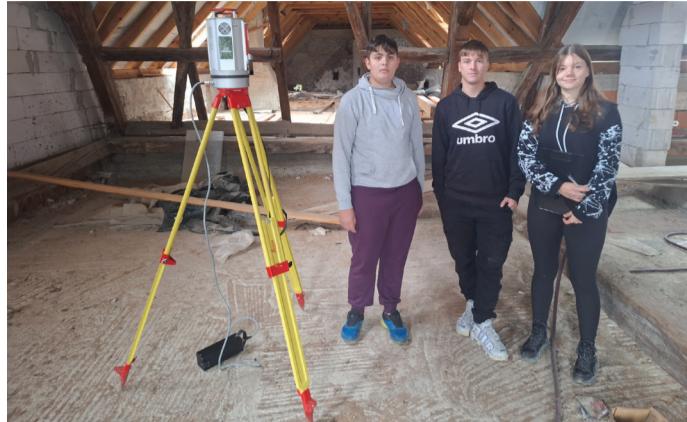
SKENOVANIE PRIESTOROV PODKROVIA
Scanning of the attic space

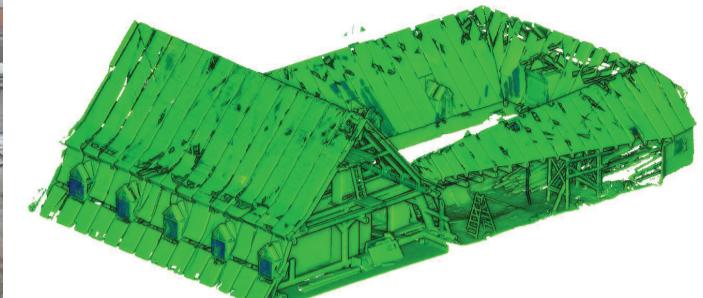
TVORBA ORTORASTOV V CLOUDCOMPAREA
Orthorasters creation in Cloudcomparea software

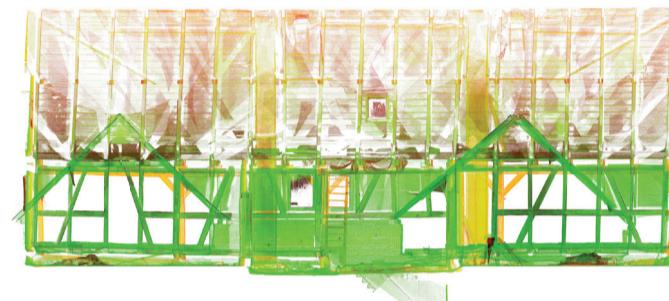
POZDĽŽNY REZOPOHĽAD TORZA HISTORICKÉHO
KROVU - ORTORASTER
longitudinal section of historical truss - orthoraster

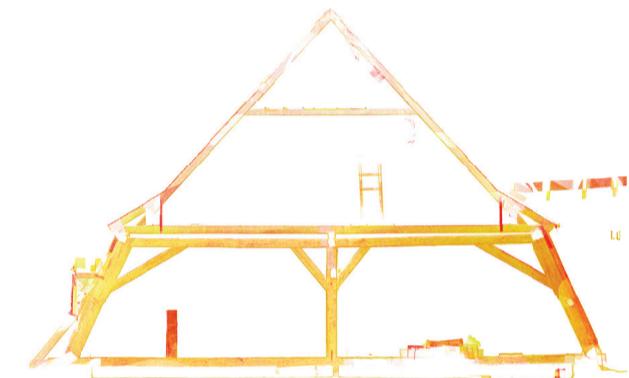
REZOPOHĽAD NA PLNÚ VÄZBU TORZA HISTOR.
KROVU - ORTORASTER
cross-section of historical truss - orthoraster

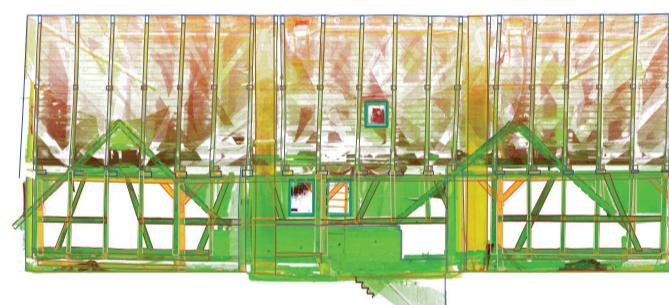
POZDĽŽNY REZOPOHĽAD TORZA HISTORICKÉHO
KROVU - VEKTORIZOVANÝ ORTORASTER
longitudinal section of hist. truss - vectorized orthoraster

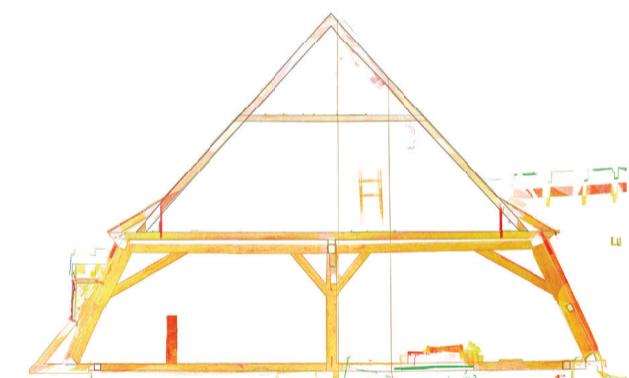
REZOPOHĽAD NA PLNÚ VÄZBU TORZA HISTOR.
KROVU - VEKTORIZOVANÝ ORTORASTER
cross-section of historical truss - vectorized orthoraster

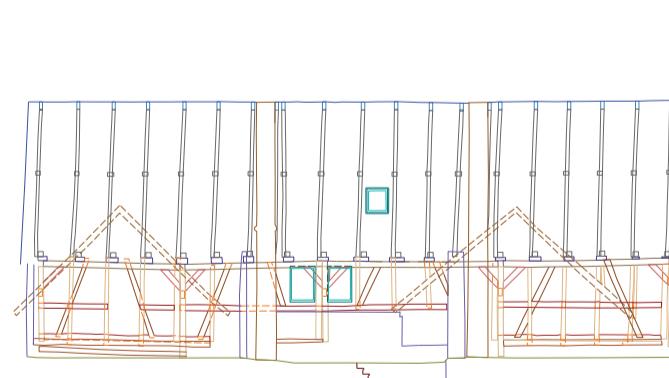
POZDĽŽNY REZOPOHĽAD TORZA HISTORICKÉHO
KROVU - VEKTOROVÁ KRESBA
longitudinal section of historical truss - vector drawing

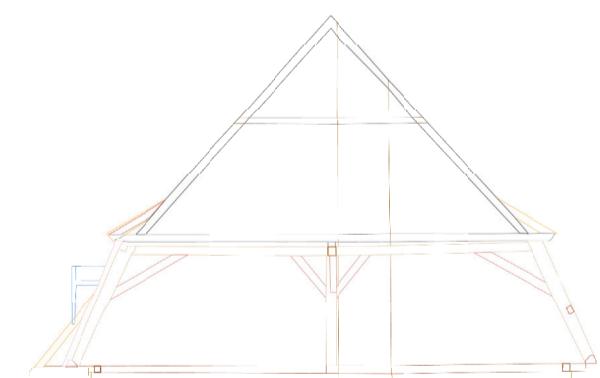
REZOPOHĽAD NA PLNÚ VÄZBU TORZA HISTOR.
KROVU - VEKTOROVÁ KRESBA
cross-section of historical truss - vector drawing

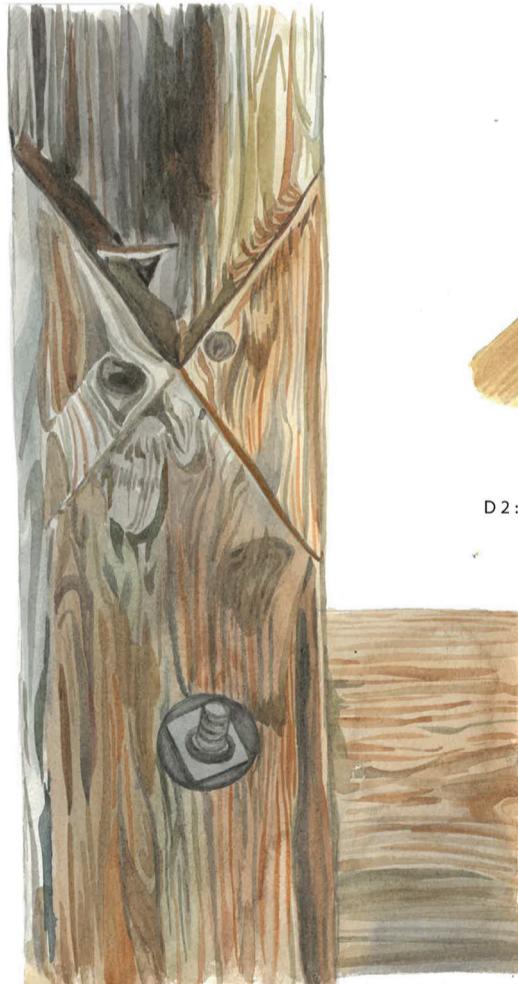
D 1: ORNAMENTÁLNE STVÁRNENIE ROZŠÍRENIA VEŠADLA

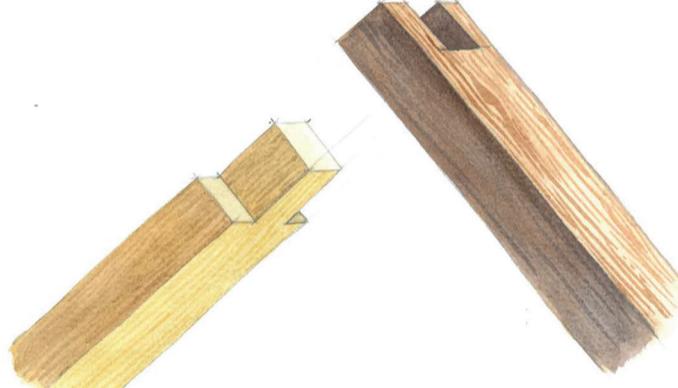
D 2 : TESÁRSKY SPOJ KROKIEV V ÚROVNI HREBEŇA STRECHY

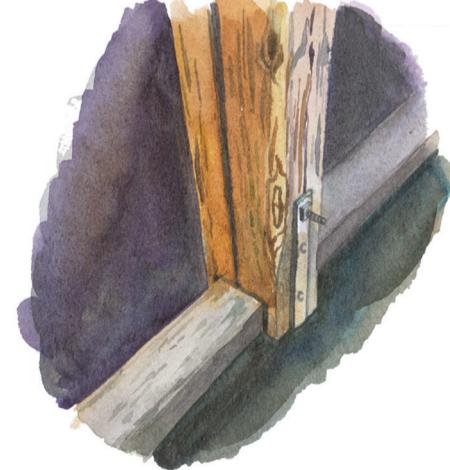
D 3 : SPOJ VEŠADLA A VÄZNÉHO TRÁMU ŽELEZNÝM SVORNÍKOM

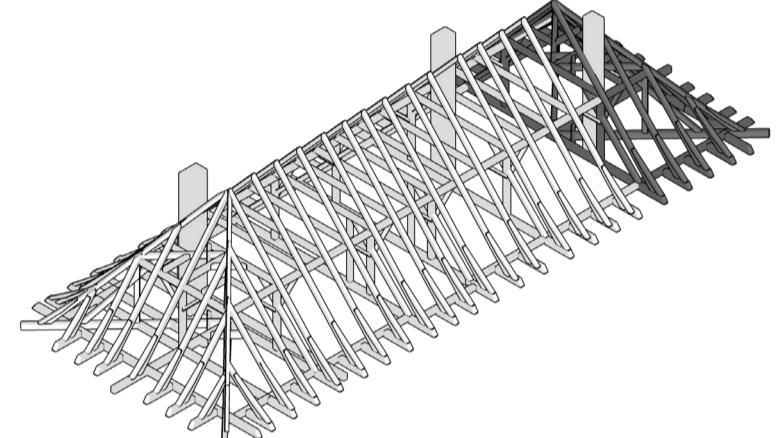
AXONOMETRIA

KROKOVÝ KROV S HAMBÁLKAMI POZDĽŽNE VIAZANÝ S DVOJITOU STOLICOU

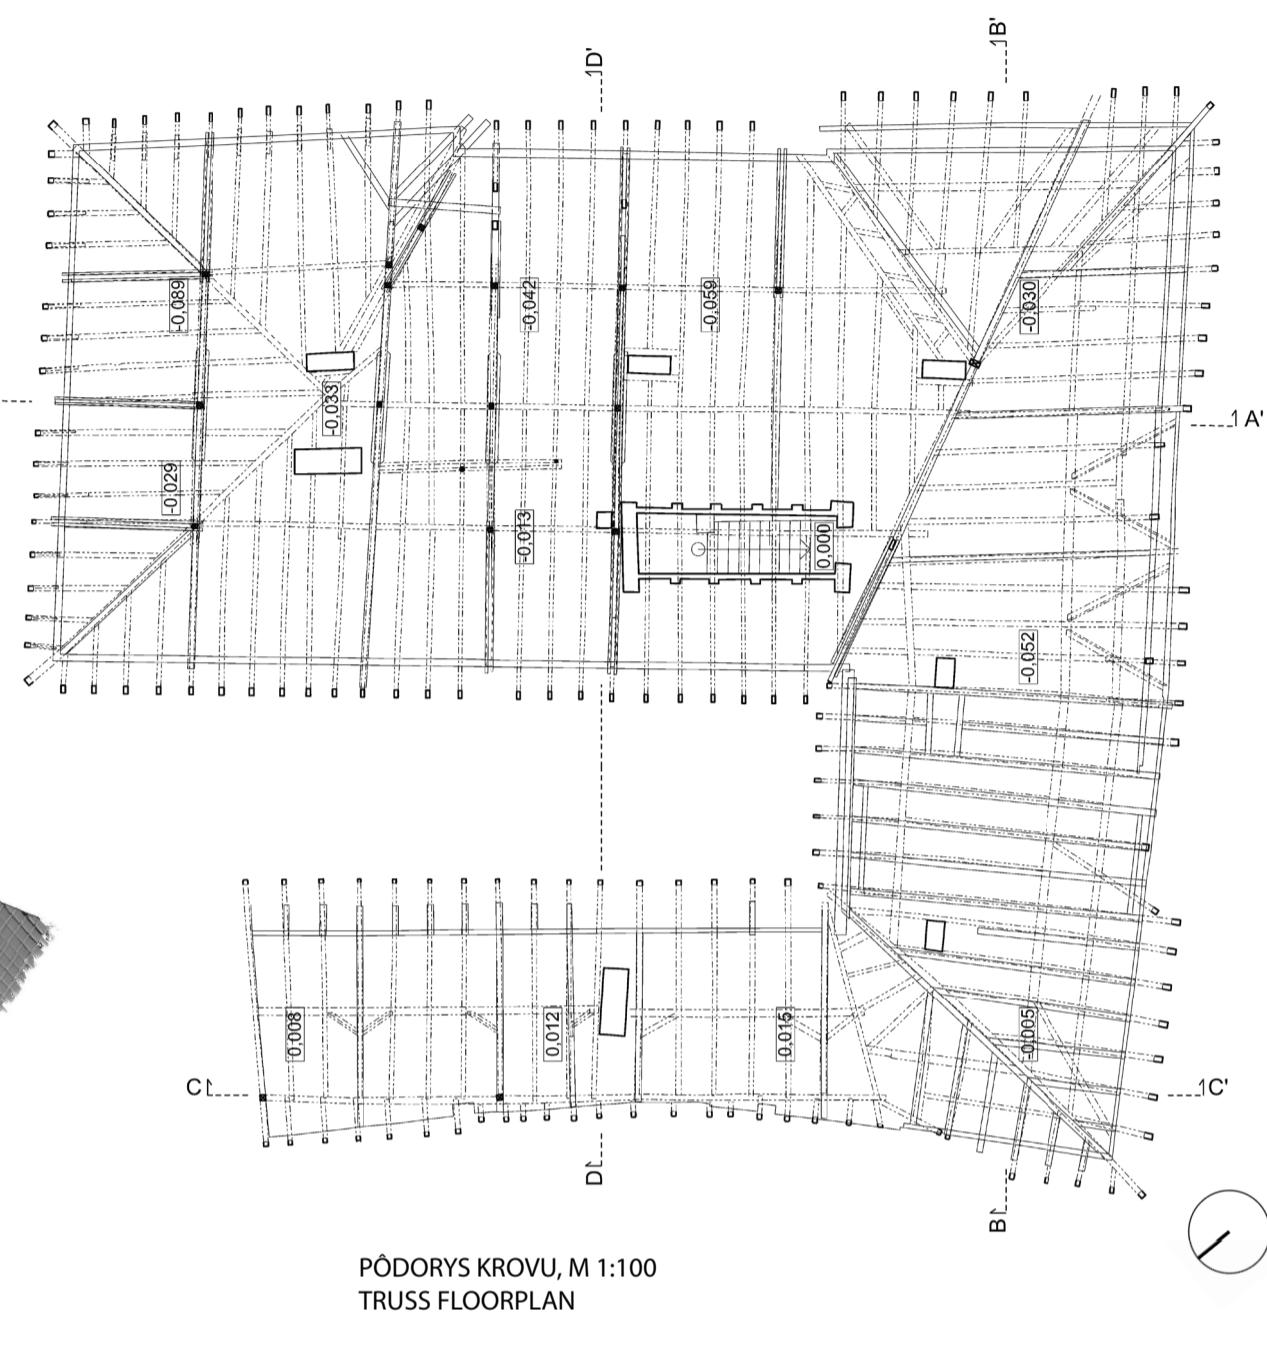
MRAČNO BODOV
POINT CLOUD

The surveying of the object was carried out using 31 survey stations, during which over 1 billion points were measured. As a result of the survey, a point cloud of the roof was created with a resolution of 2 mm. Subsequently, the point cloud was vectorized, resulting in a cross-section and a longitudinal view.
